WEEKLY STATUS REPORT

BCP Project No.:	C224099	EPA Consent Order No.:	CERCLA-02-2017-2021	Date:	11/22/2019
Project Name:	BRT Powerhouse 153 2 nd Street AKA 322 3 rd Avenue, Brooklyn, NY 11215				
Remediation Activities (Week of November 18, 2019): <ul style="list-style-type: none">Continued gauging and product recovery via absorbent sock as necessary.Clean Harbors (Site remediation contractor, U.S. EPA ID Number MAD039322250) removed thirty-six (36) drums of hazardous PCB material from the Site. Drums were transported to Clean Harbors Deer Park, LLC (U.S. EPA ID Number TXD055141378), located at 2027 Independence Parkway South, La Porte, TX 77571 for disposal. Drums were generated during the decontamination of the groundwater treatment system.					
<ul style="list-style-type: none">Redevelopment Activities (Week of November 18, 2019):Maspeth Welding (Site steel contractor) continued steel repair work in the turbine hall.Domani and Garden State Surveying, Engineering, and Planning (Site survey contractors) continued site surveying work as necessary.Structure Tech (Site foundation contractor) completed breakdown and decontamination of groundwater treatment system.Structure Tech began

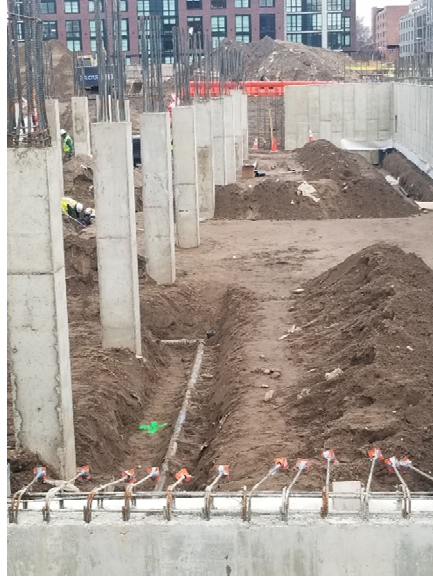
Photo 1 – Looking north west at the boiler house slab. Plumbing is being installed in trenches dug into the soil.

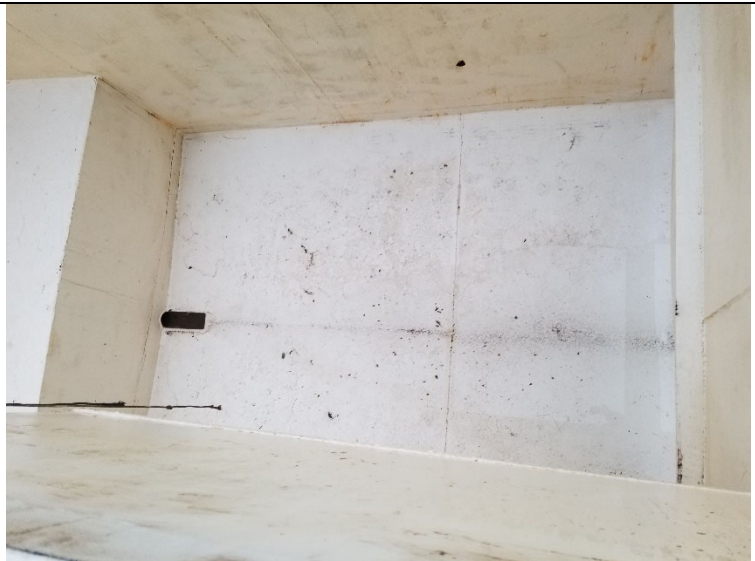
Photo 2 – View of the groundwater treatment system's influent tank after decontamination.

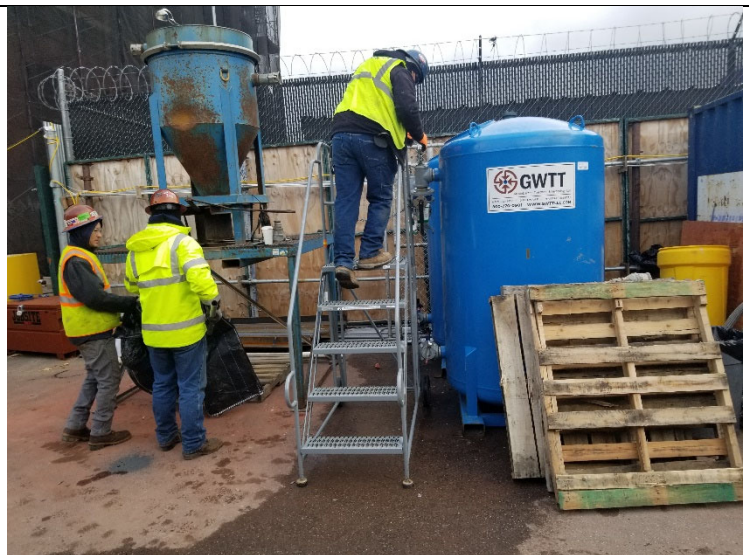
Photo 3 – Ground/Water Treatment and Technologies prepares to remove carbon from GAC filters.
